# Health Consultation

NORTH RIDGE ESTATES  
(a/k/a FORMER MARINE RECUPERATIONAL BARRACKS)

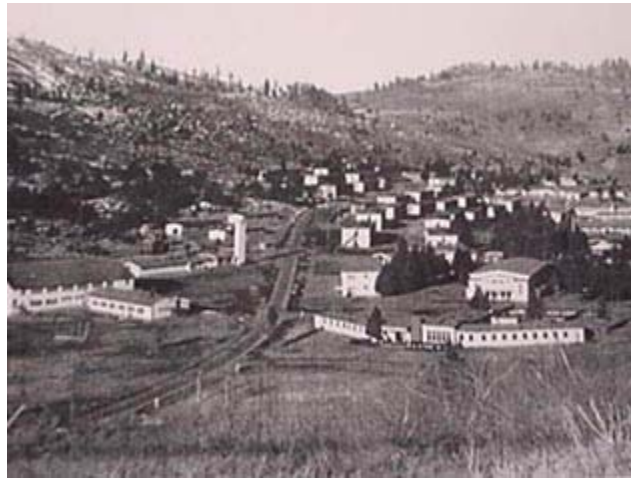
(Photo courtesy of the Klamath County Museum)

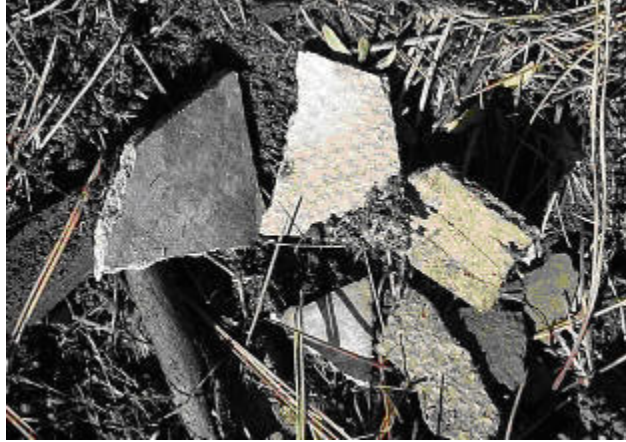
**Vinyl floor tiles (VAT)** are 9 by 9 inch tiles that were used on concrete and wooden floors of the former Marine Barracks buildings. Some tiles are red with white swirls, and others are blue. Broken VAT can come in many different platy shape sizes, and may have flat or curved shapes.

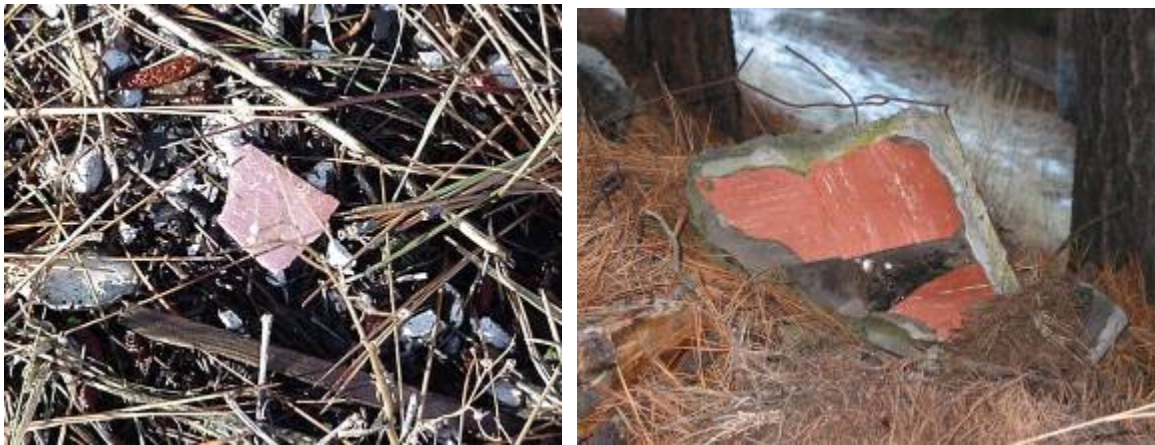
**Roofing material** from the former Marine Barracks buildings is gray and black (the black material is tar).

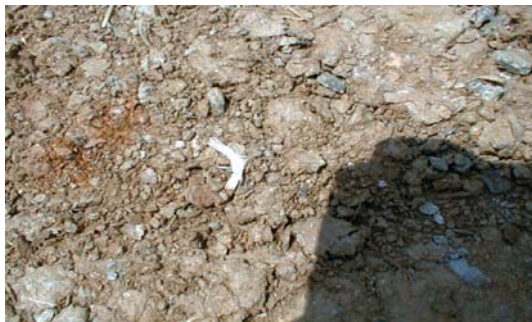
### **WHEN IS ASBESTOS DANGEROUS?**
